Manhole Inspection Summary

Manhole # S53K__014MH

Insp Date: **4/8/08 12:11 PM**

Location Address: **3305 Clyde st**

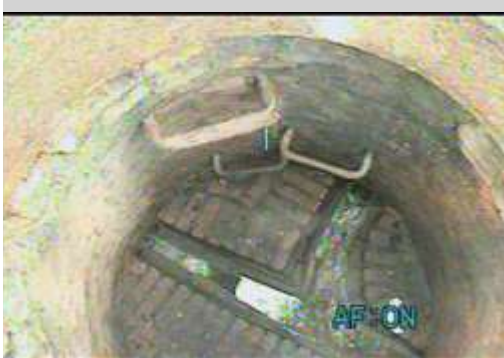
Defect 2

Steps Count: **3** Missing: **0** ☒ **Corroded**

steps corroded

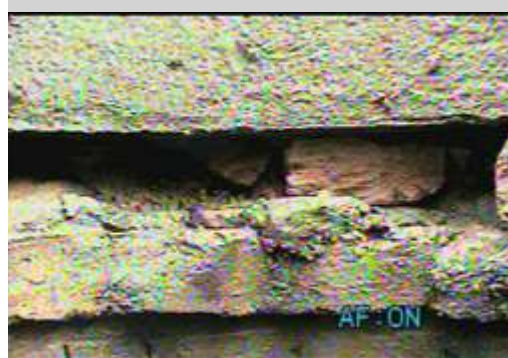
Defect 1

Condition: ☐ Sound ☐ Cracked ☐ Root Intrusion ☒ **Loose Brick** ☒ **Deteriorated**

chimney loose bricks deteriorated, frame adj

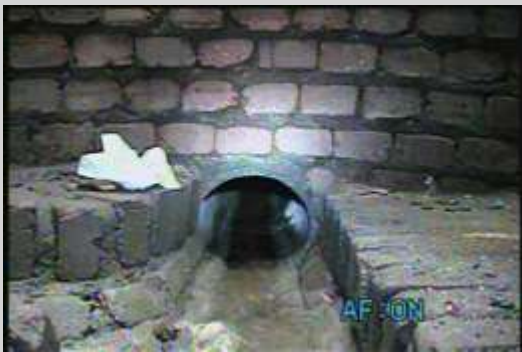
12 O'Clock Outflow

8 in. Circular Gravity Sewer
Pipe Out @ 12 O'Clock

Pipe Material: **Clay** ☐ Pipe Lined

Deposits: ☒ None ☐ Mud ☐ Sludge ☐ Debris ☐ Grease

Infiltration: **None** Pipe Seal Cond: **Unknown**

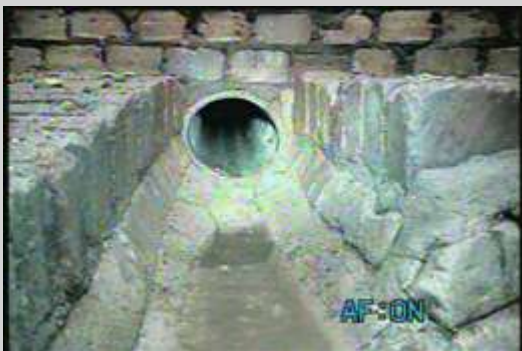
6 O'Clock Inflow

8 in. Circular Gravity Sewer
Pipe In @ 6 O'Clock

Pipe Material: **Clay** ☐ Pipe Lined

Deposits: ☒ None ☐ Mud ☐ Sludge ☐ Debris ☐ Grease

Infiltration: **None** Pipe Seal Cond: **Unknown**

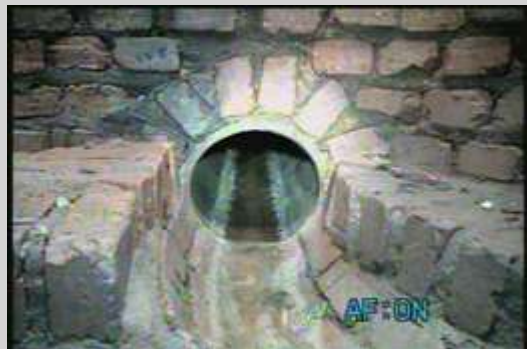
9 O'Clock Inflow

8 in. Circular Gravity Sewer
Pipe In @ 9 O'Clock

Pipe Material: **Clay** ☐ Pipe Lined

Deposits: ☒ None ☐ Mud ☐ Sludge ☐ Debris ☐ Grease

Infiltration: **None** Pipe Seal Cond: **Unknown**
